SUBJECT Technical Report on MIG-15 BIS

TECHNICAL REPORT  
ON  
MIG 15 BIS  
NO 1327

PART ONE  
AIRFRAME

The following report is based upon information gained from examination of a Polish built aircraft (known as "FAGOT"), designated LIM-2 (Polish designation for the USSR MIG-15 Bis) 25X1

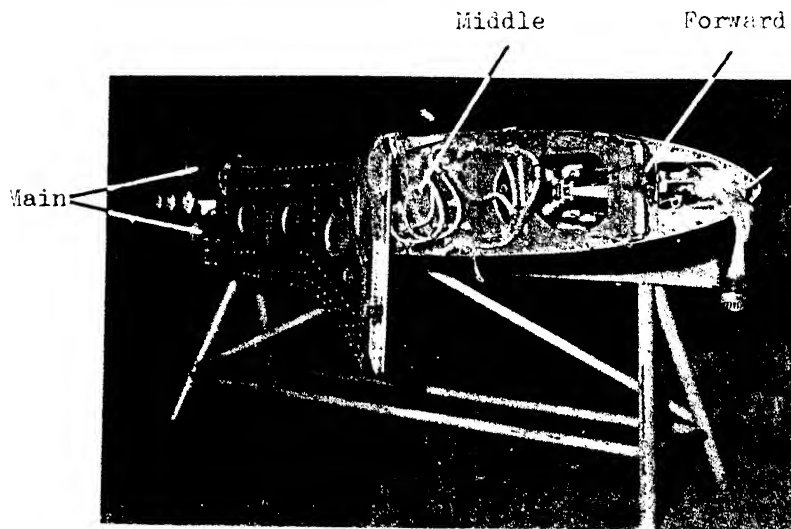
Photo no. 15. Wing to fuselage fittings.

- a. There were two other single pin attachments of the wing to the fuselage. One at about 12% chord and the other at about 35% chord. The center of the forward fitting was 2 cm below centerline and the center of the rear fitting was 0.7 cm below centerline, therefore both were load carrying. Each was fitted with an eccentric cam which can be rotated for making minor adjustments in the angle of incidence. The fit of all pins was moderately loose. The diameter of the forward pin was 18 mm and of the rear 12 mm. The adjusting arm of the forward eccentric cam could be moved through an angle of  $120^\circ$ ,  $-60^\circ$  or to  $+60^\circ$  from the horizontal zero position. The arm could be locked at the zero position and at plus or minus  $20^\circ$ ,  $40^\circ$ , and  $60^\circ$ . The eccentricity of the outside and the inside diameters was 1.5 mm, giving a maximum vertical movement of 1.3 mm at the  $60^\circ$  positions. The eccentricity of the rear cam was, of course, in proportion to and less than that of the forward cam. Note: Incorporation of the additional center pin would provide greater torsional strength to the wing root section. Note: The modification was reported by the pilot to be accomplished at unit level. Close examination of the work confirmed this and further indicated the use of modification kits.

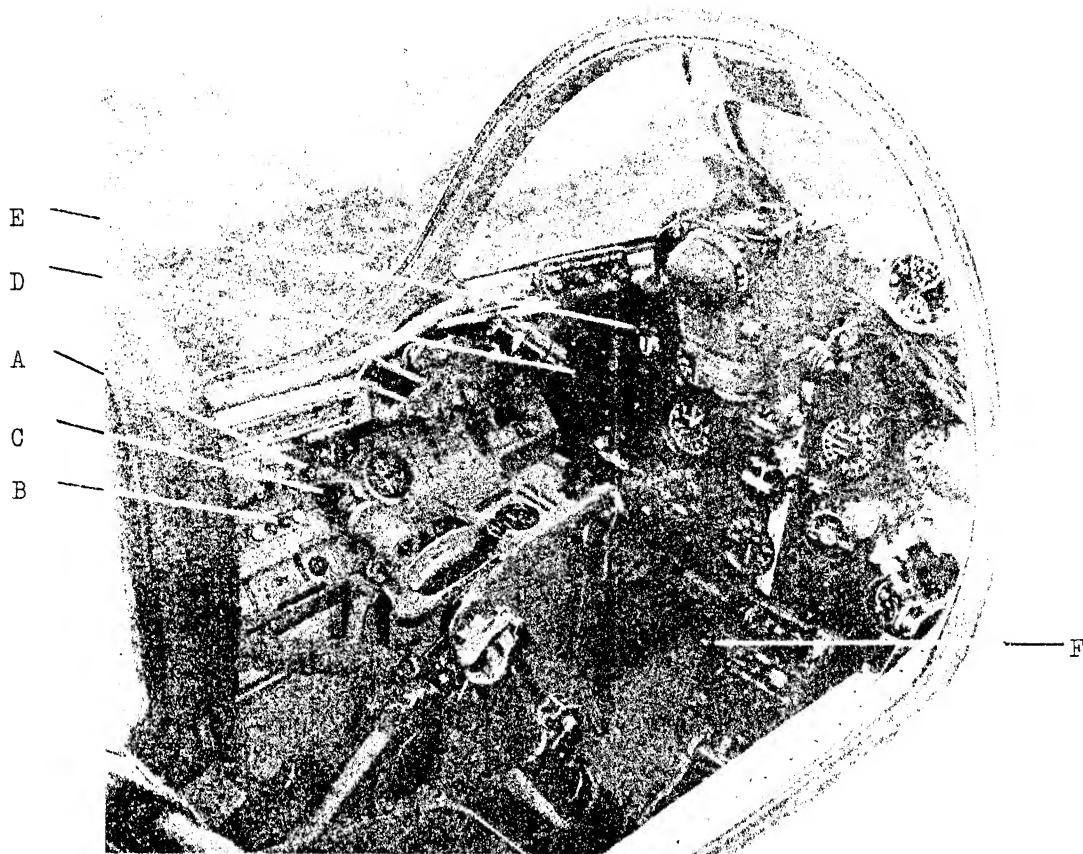
Photo no. 24 - Cockpit, Left console

- A. VHF Control box
- B. Signal Flare discharger
- C. Three position rotary switch
- D. Undercarriage master switch
- E. Combined oxygen pressure gauge-blinker
- F. Extra brake lever.

- b. Items 6 and 8 have been removed and replaced by the signal flare discharger switch and firing buttons (items 7 and 9).
  - c. A VHF control box is now located where items 7 and 9 used to be.

- d. Item 85 has been removed and incorporated in VHF control box.
  - e. Tripple toggle switch, item 8, has been replaced by a three position rotary switch.

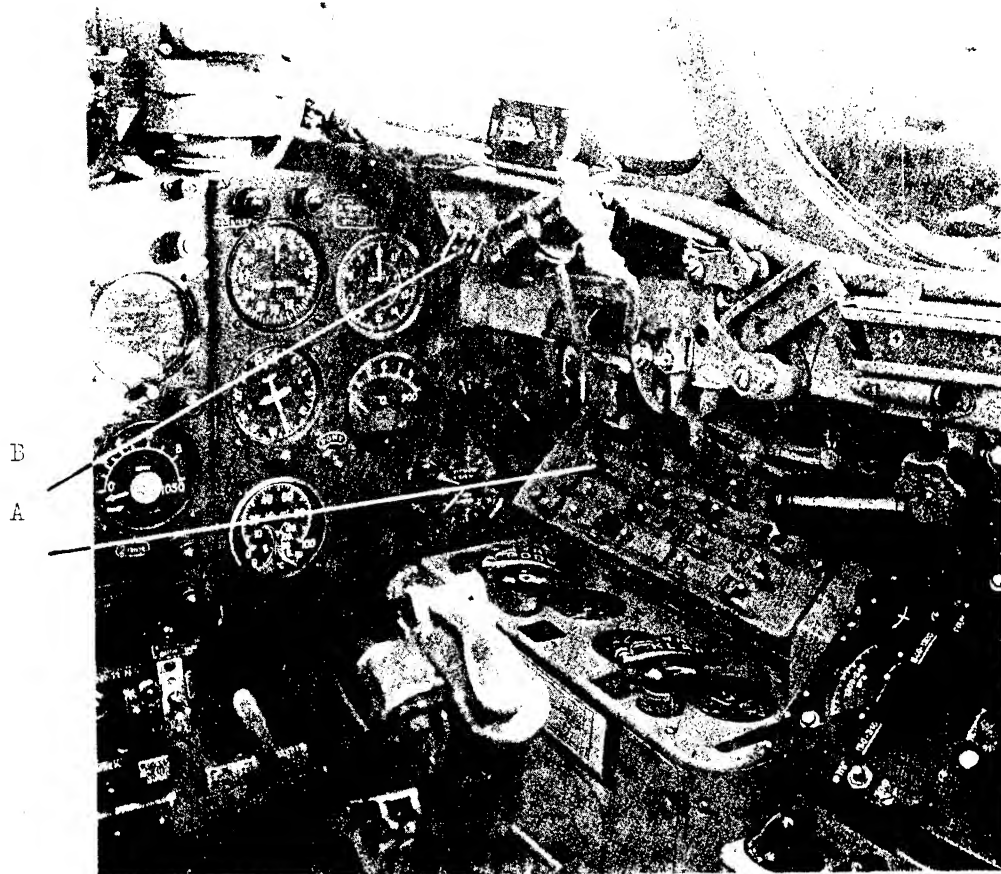
Photo no. 26 - Cockpit. Right hand console.

A. Master switch for landing light.

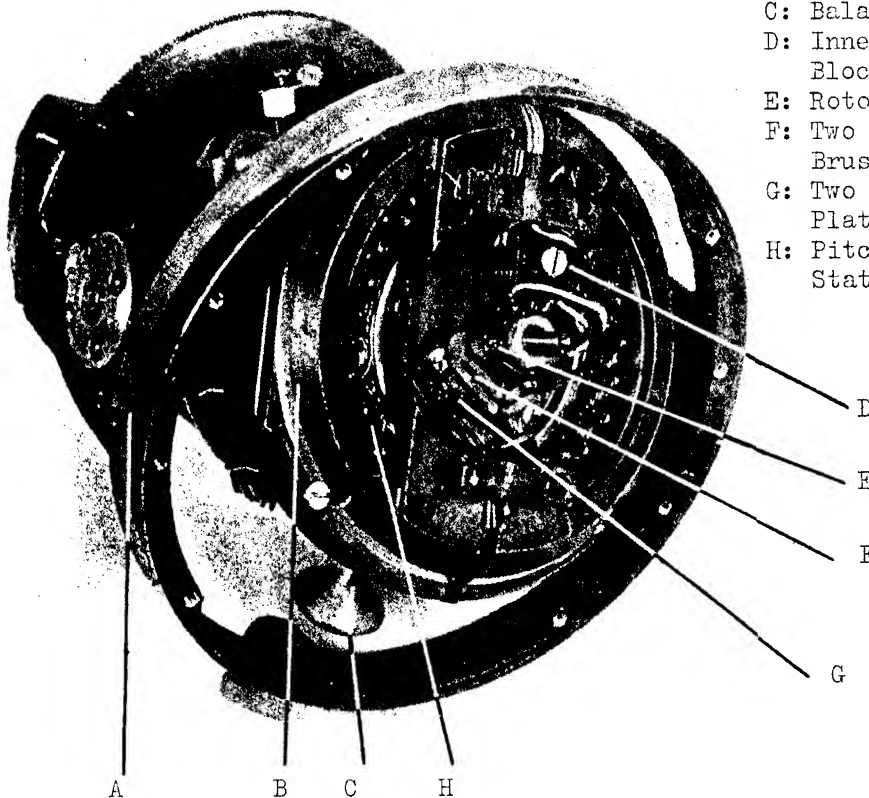
Photo no. 51.  
Gimbal Rings.

- A: Outer Gimbal Ring.  
 B: Inner Gimbal Ring.  
 C: Balance Weight.  
 D: Inner Gimbal Brush  
 Block.  
 E: Rotor Housing Slip Rings.  
 F: Two Phase Motor Control  
 Brushes.  
 G: Two Phase Motor Contact  
 Plates.  
 H: Pitch Torque Motor  
 Stator Windings.

This gimbalring is situated inside the outer gimbalring (photo no. 51 pos. B) carried by the abovementioned two ball bearings. To the left side is attached the Stator windings of the abovementioned torque motor, on the right side axle is found the slip ring assy, corresponding to the abovementioned brushes.

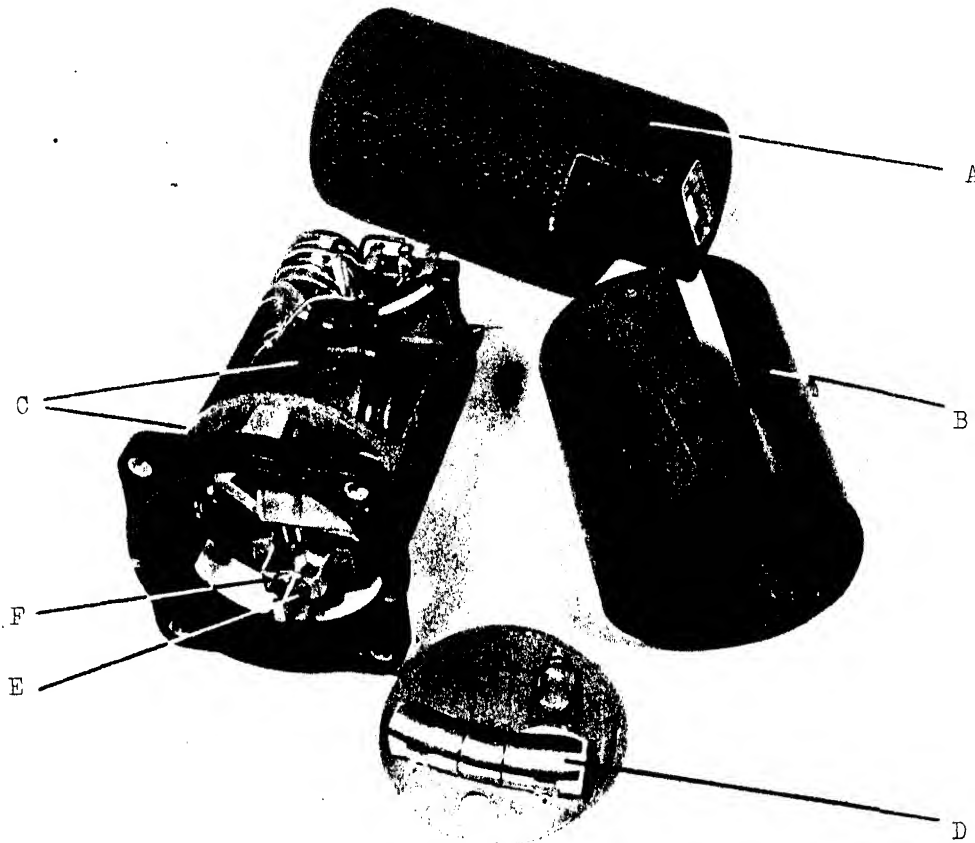
Photo no. 55.

- A: Cover.
- B: Screen.
- C: Instrument Frame and Rotor Housing.
- D: Bank Indicator (from the rear side).
- E: Pointer Axle Bearing Bushing.
- F: Mounting Bracket.

Inside the front part is found the pointer axle supported in a bearing bushing (photo no. 55 pos. E). mounted on a Ushaped bracket (photo no. 55 pos. F). The fork-shaped pointer axle arm (photo no. 56 pos. C) is connected to a spigot attached to a circular plate mounted on the rotor housing.

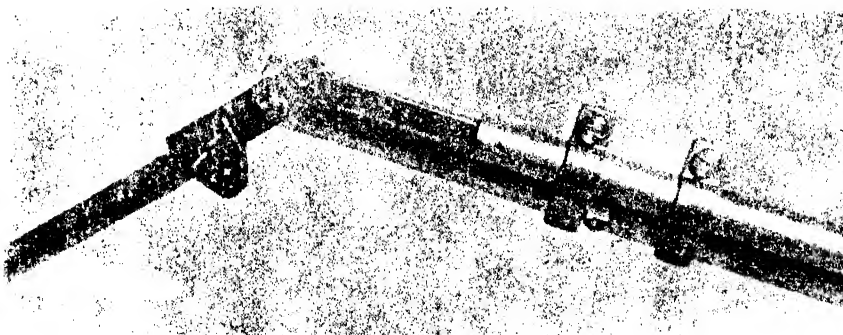
Photo no. 67.

Fuel Transmitter Stop.

2. The fuel contents system was the same as found previously, with the exception that the fuel transmitter top and bottom stops were positioned on the fixed transmitter arm (photo no. 67.)

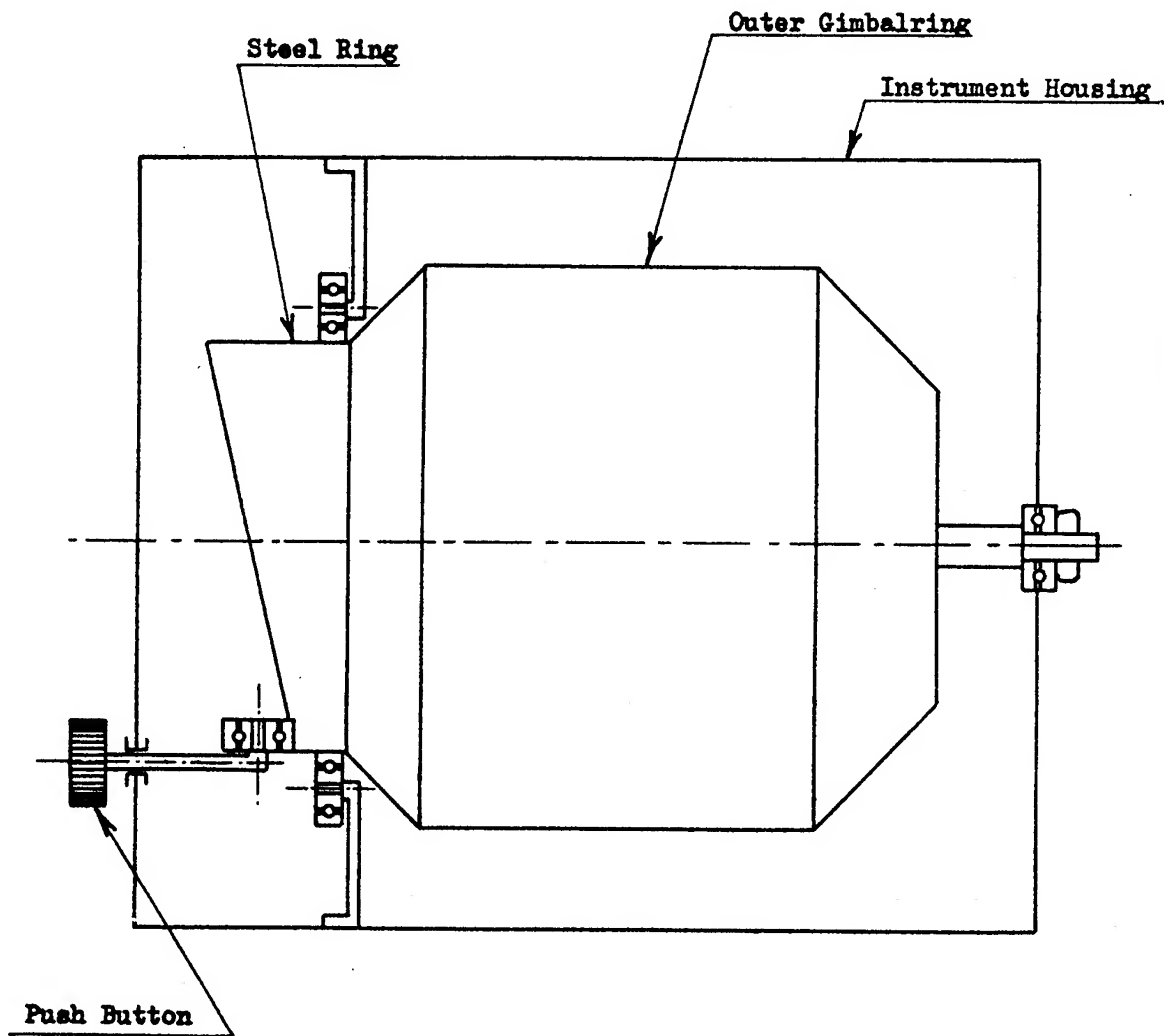
Dwg. no. 61.

Outer Gimbal Caging Mechanism  
Schematic.

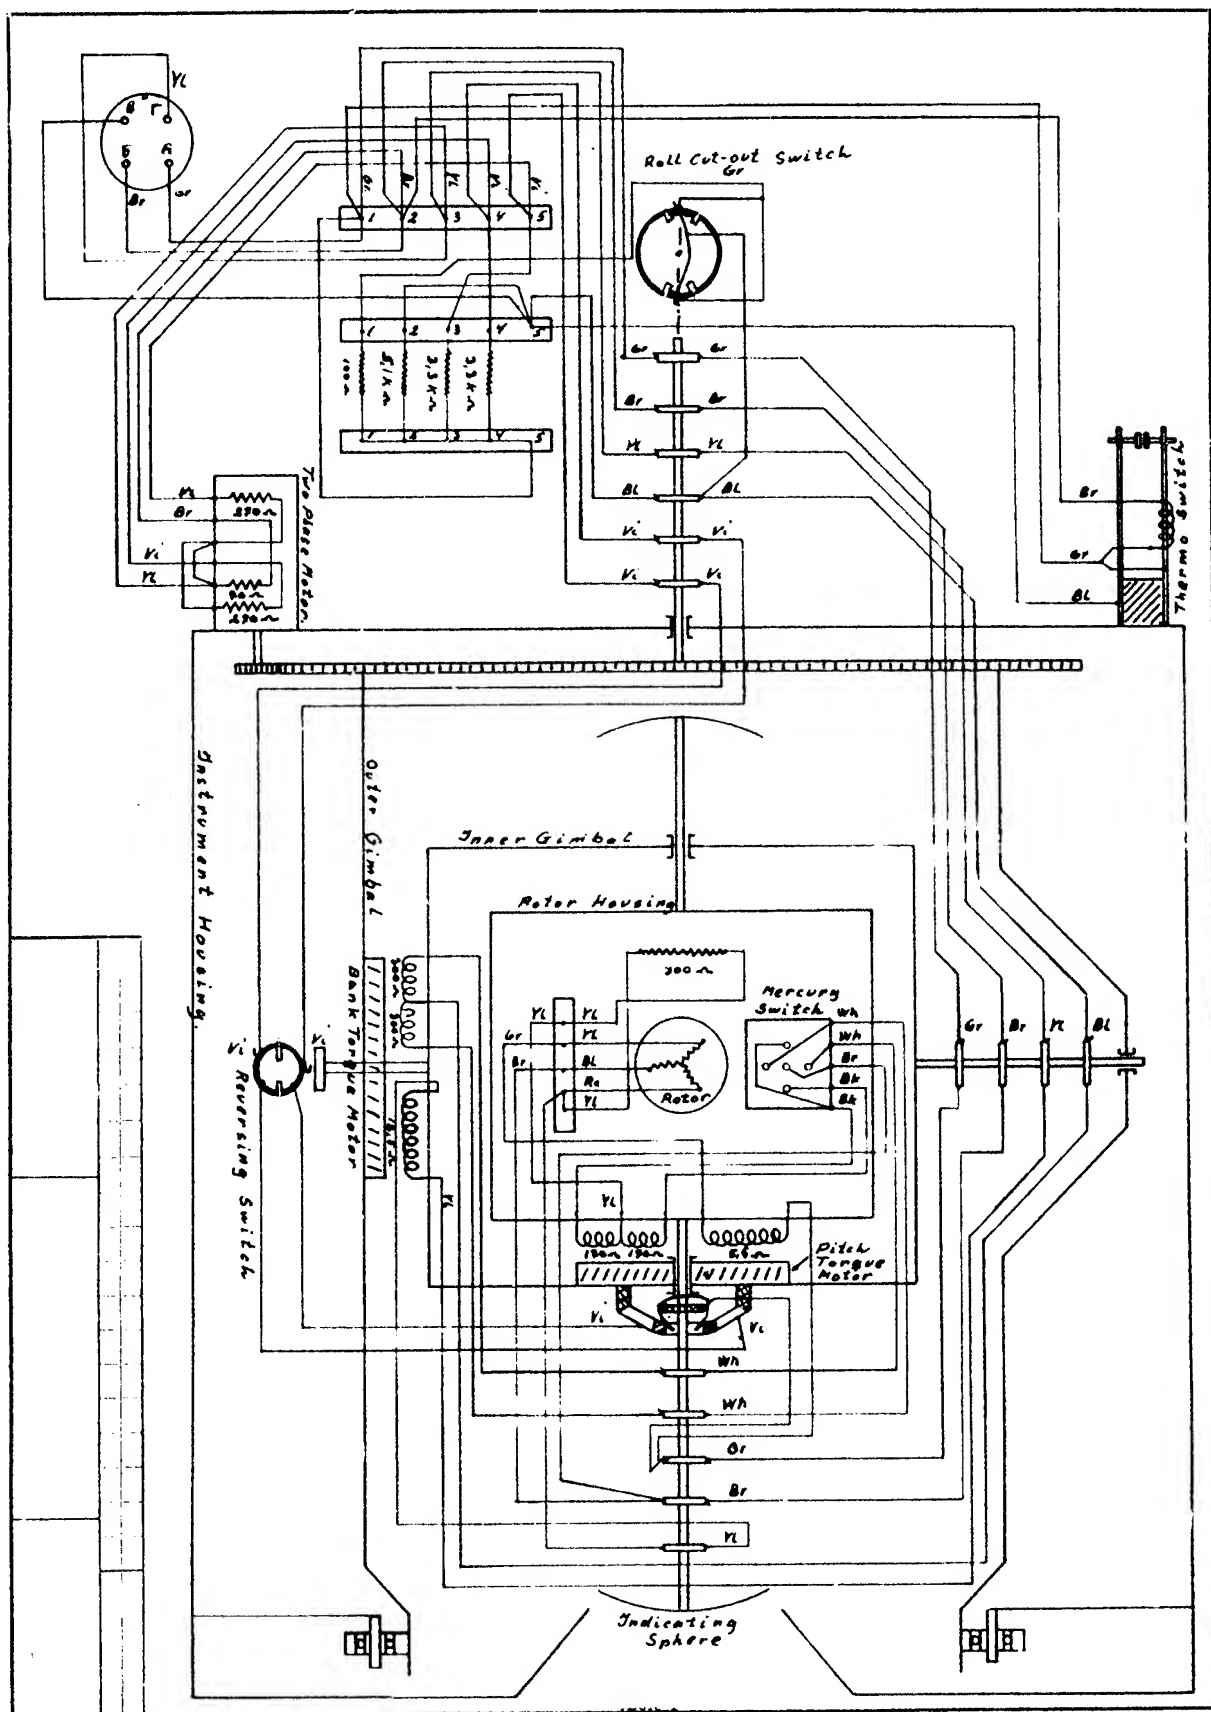
Dwg. no. 62.

## Gyro Horizon Wiring Diagram.

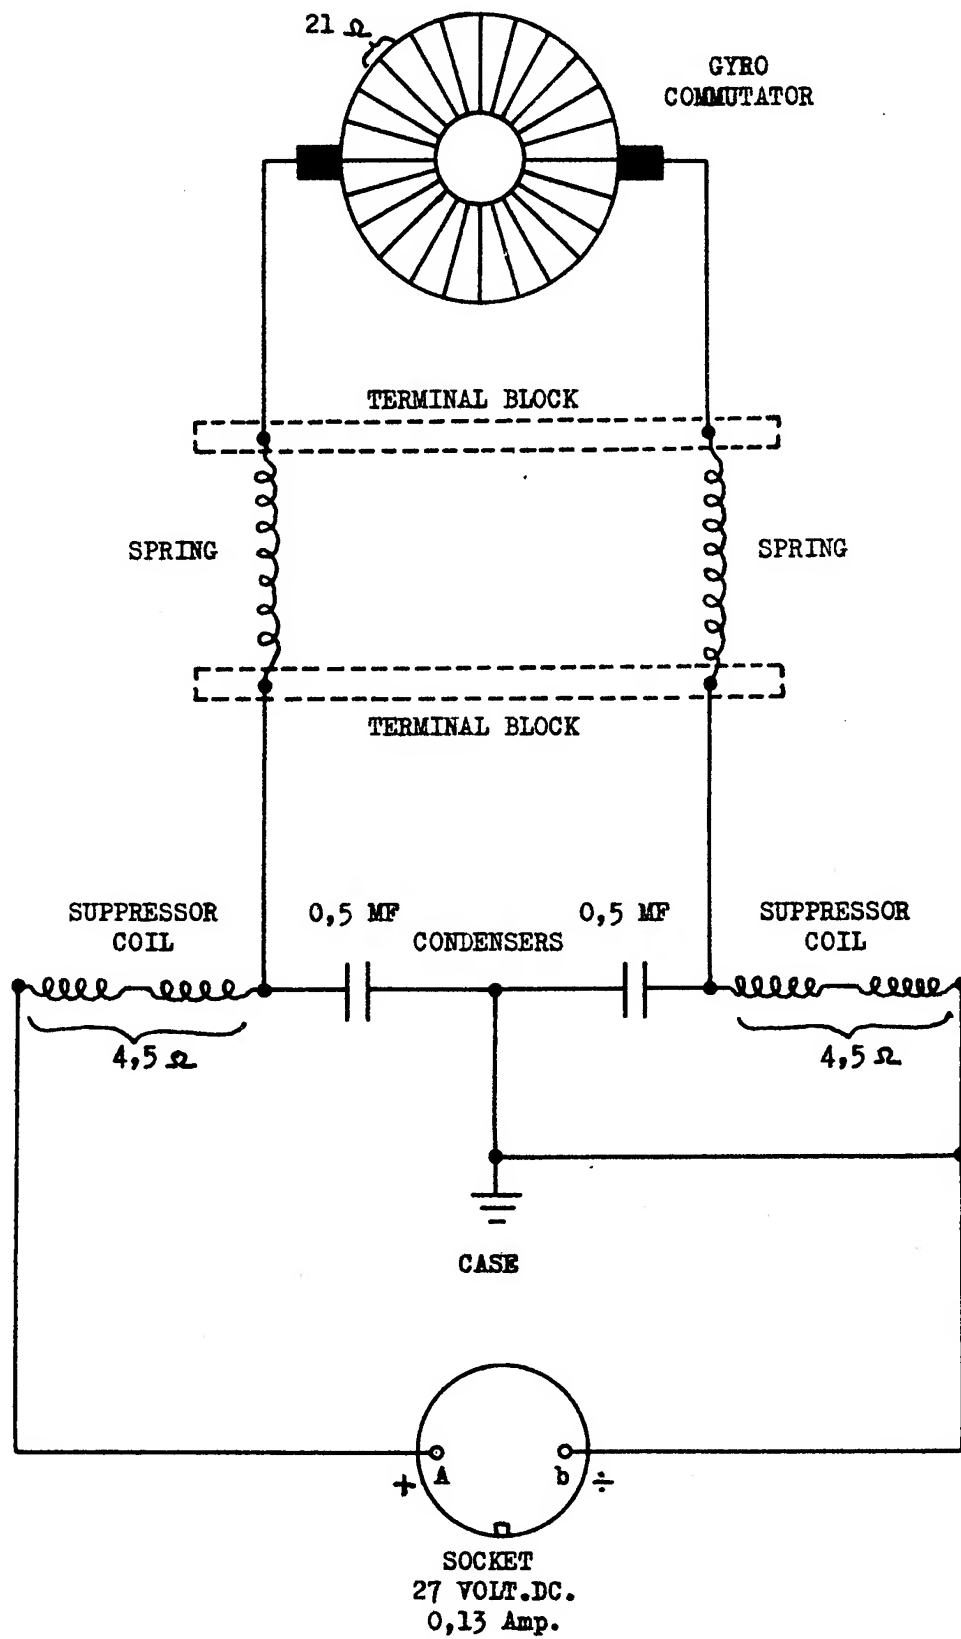
Dwg. no. 63.

Turn and Bank Indicator,

## Wiring Diagram

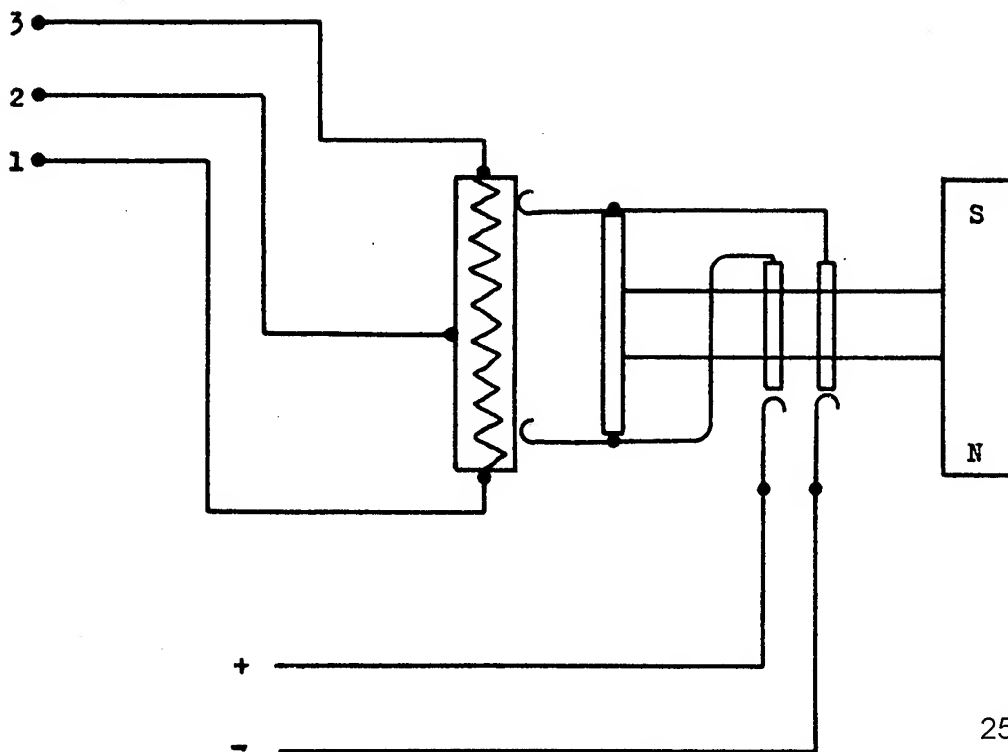
Dwg. no. 66.

Compass Transmitter  
Wiring Diagram.

The two-pin and three-pin plugs are the same as those found previously, but the connections inside the transmitter are slightly different (dwg. no. 66).

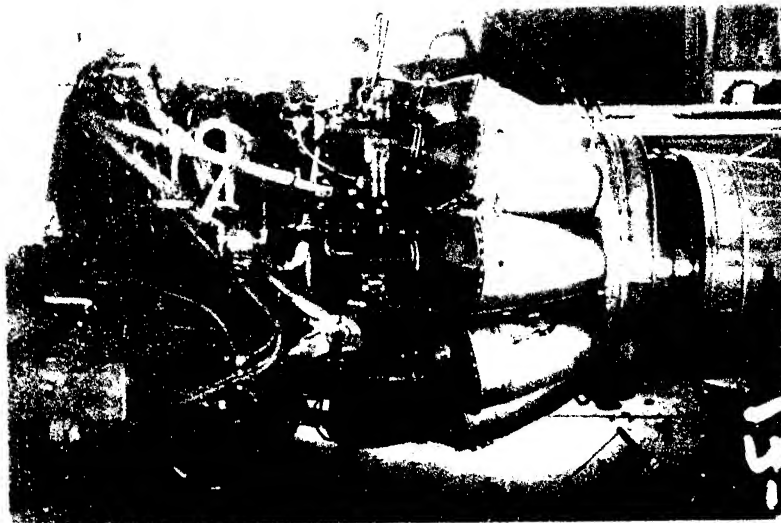
Photograph 4. LIS-2 Engine - Attachment Points.

The method of engine mounting was identical to the previous cases, except for slight dimensional differences in lengths of supporting members. [ ] the upper supporting strut in this case was measured to be 31.25". The intermediate support was 41.0" and the lower support 36.5" in length, center to center.

The vertical distances between mounting points on both engine and fuselage were found to agree with those previously measured i.e. 16.25" and 41.0" respectively.

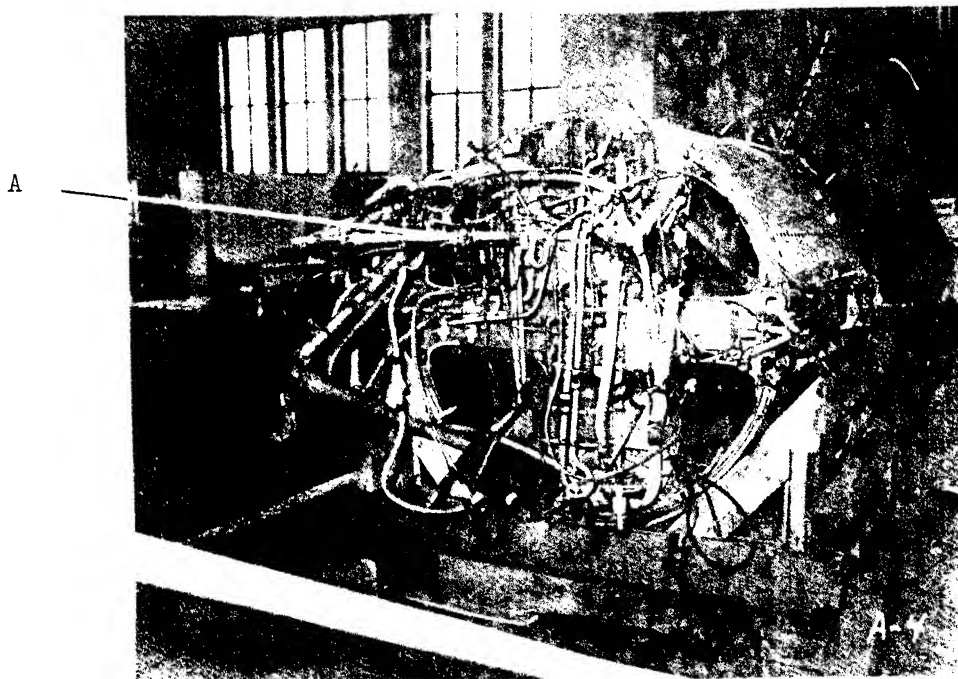
Photograph 10 Fuselage at Frame 13.

A. Auxiliary Gearbox Drain Valve.

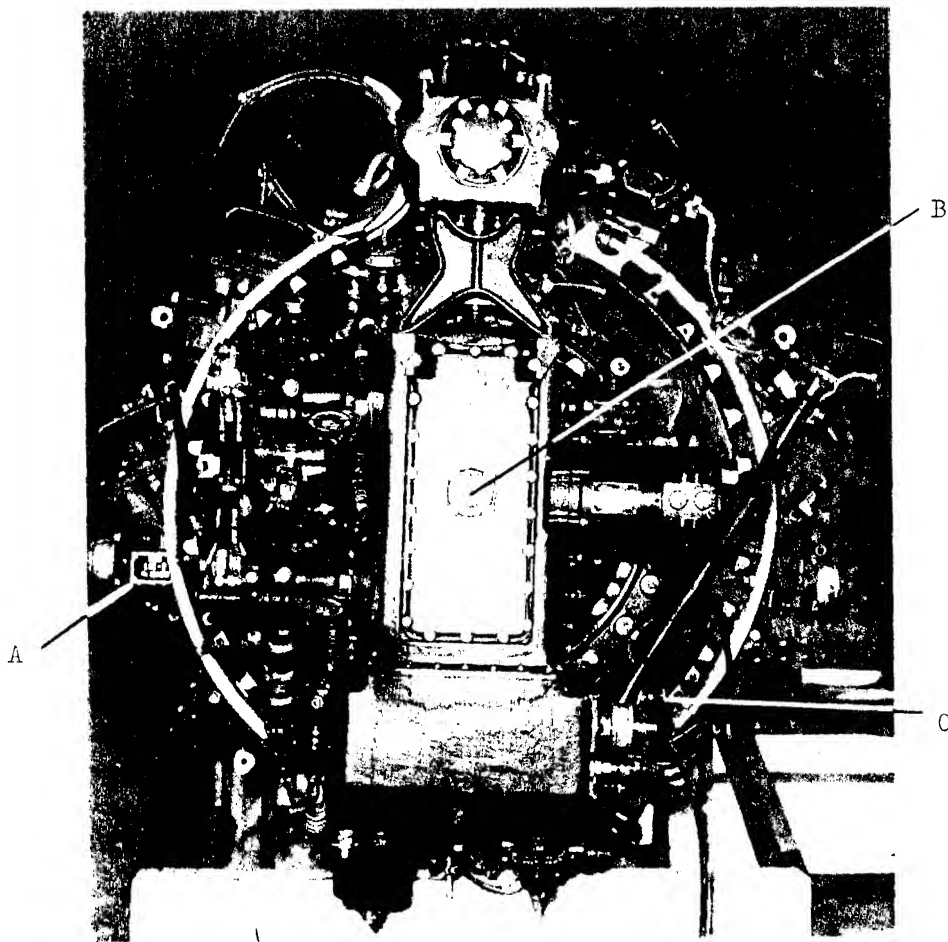
Photograph 11. LIS-2 Engine - Front View

The breather on this engine was located in the central pad on the front face of the wheelcase [REDACTED]  
The breather tube [REDACTED] was not present on this aircraft.

- A. Engine Data Plate
- B. Breather
- C. Push-button Oil Level Valve.

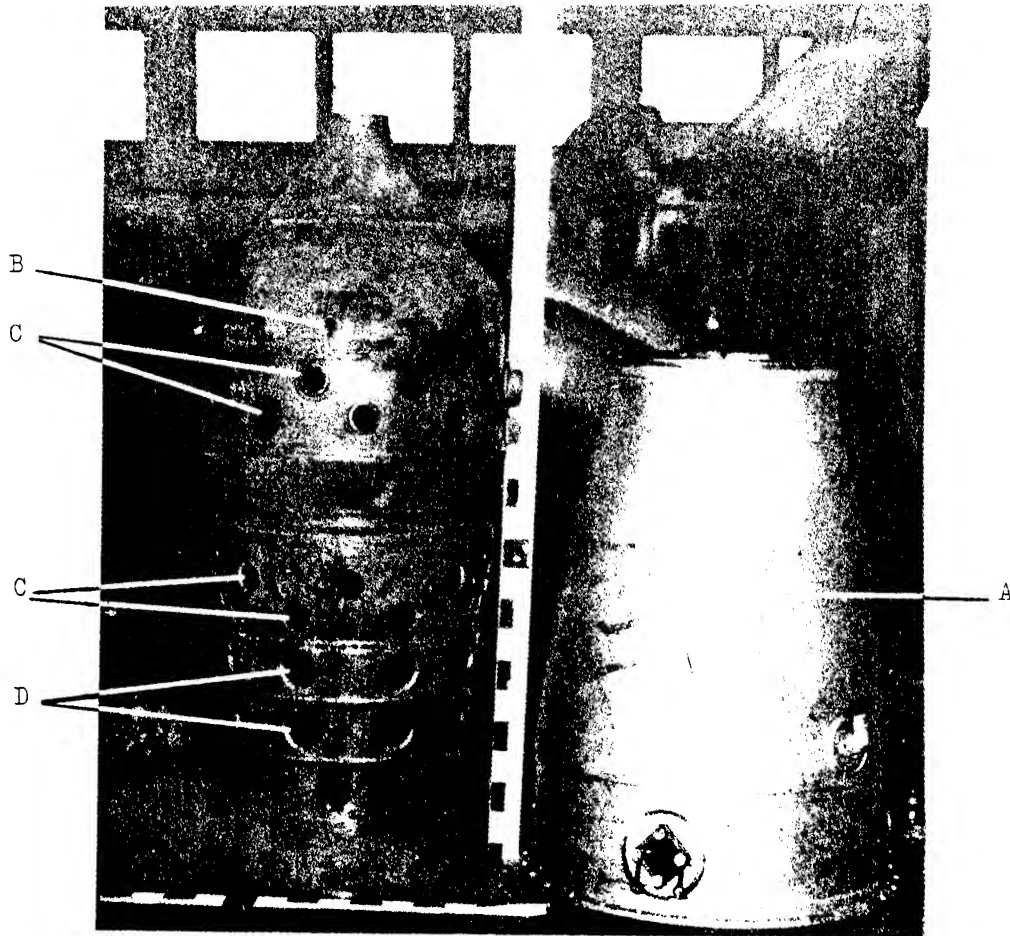
Photograph 14. Air Casing and Flame Tube

Although the dimensions of the air casing remained the same as previously, a different fabrication technique was employed. Instead of the helical weld construction of the previous cans, these air casings were made of two sections joined by a circumferential seam. Each of the two sections was apparently formed by deep drawing from a single piece. The seam joining the two sections was overlapping, spot welded, and brazed to seal the joint. The front flange on the casing was also attached by this method, i.e. spot welded and brazed. The rear flange was attached by means of a continuous resistance weld.

- A. Single-piece conical section of air casing.
- B. Dimpled keyhole slots.
- C. Reinforcing eyelets.
- D. Flanged holes.

The following differences were noted on flame tube construction (see photograph 14):

- a. The edges of the holes in the rear two rows were turned inwards to form a stiffening flange.
- b. Four rows of holes were eyelet reinforced similar to rows 3 and 4 of the previously observed engines.
- c. The keyhole slots in the front conical section were dimpled slightly inward at the rounded end of the slot.

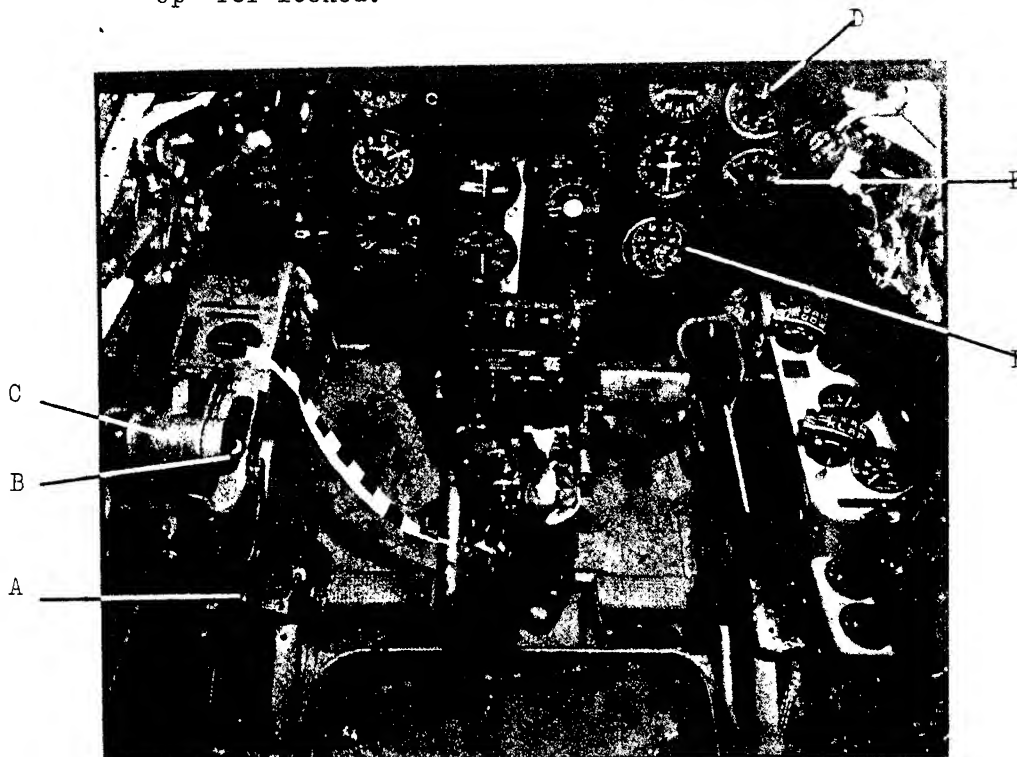
Photograph 19. LIM-2. Cockpit Layout

- A. Throttle lever friction control (In "free" position).
- B. Engine starter button on throttle lever.
- C. Throttle lever in closed position.
- D. R.P.M. Indicator.
- E. Jet Pipe Temperature gauge.
- F. Engine gauge unit.

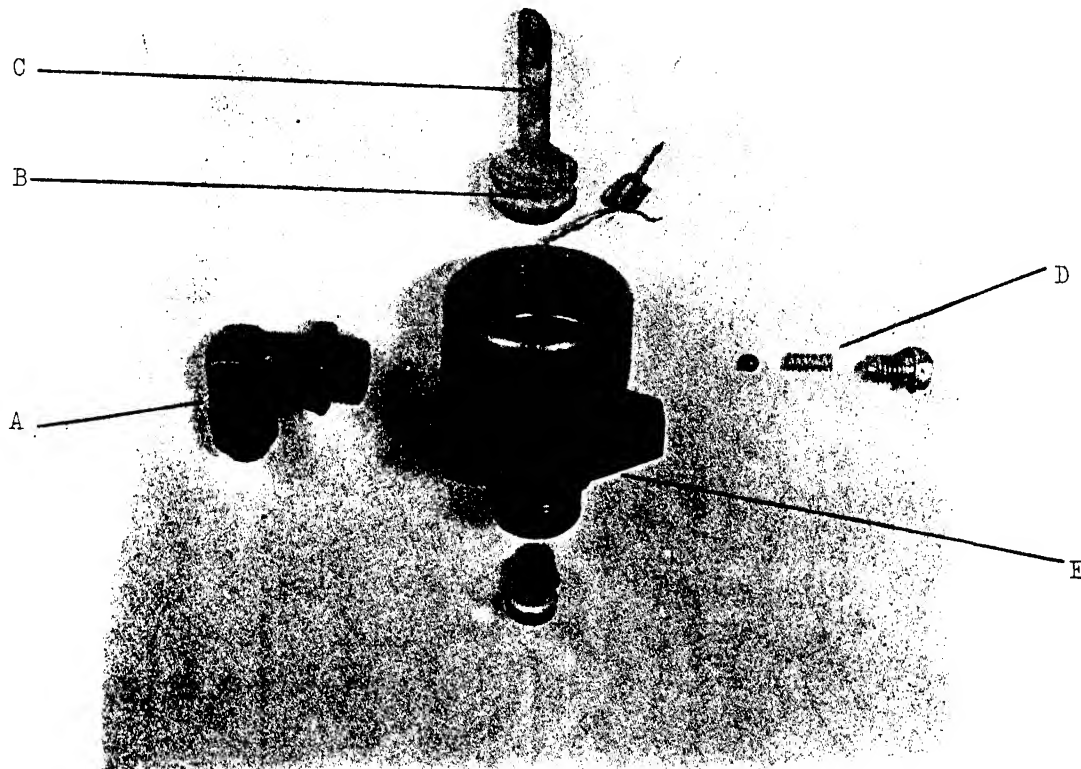
Photograph 27. Fire Extinguisher Bottle Head.

the exploded view in photograph 27 is included to clarify its build-up and operation.

- A. Outlet elbow to spray pipes.
- B. Circumferential groove.
- C. Hollow diaphragm-piercing knife.
- D. Spring-loaded ball for restraining free movement of knife.
- E. Body of head fitting.

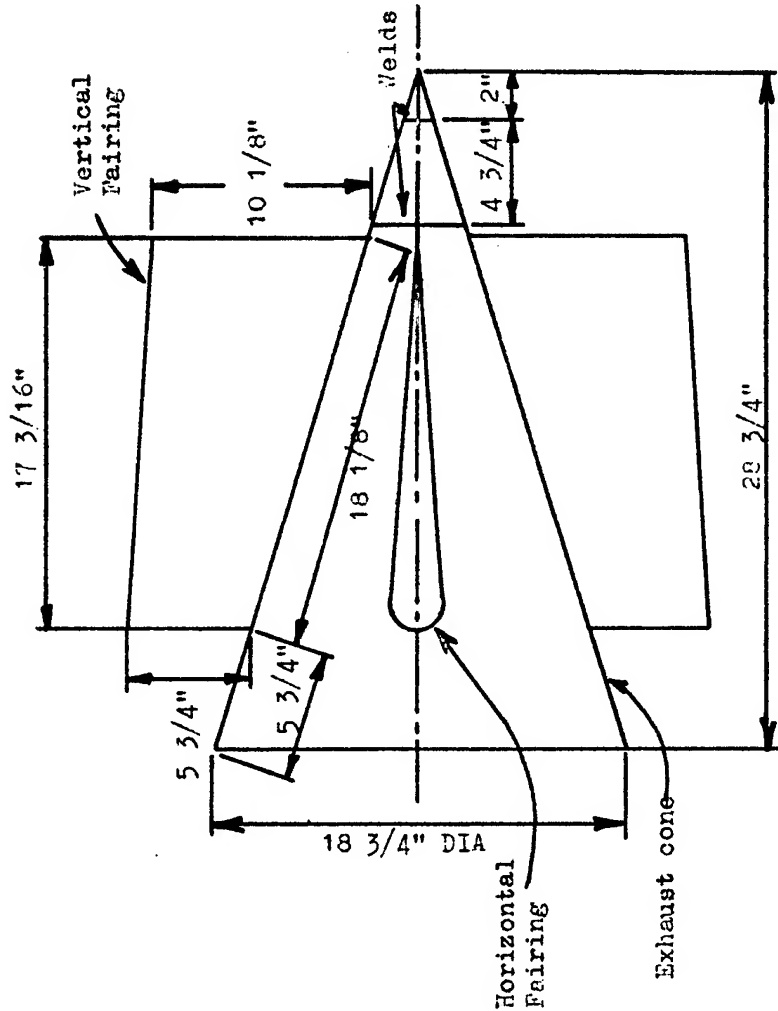
Dwg. no. 16.

EXHAUST CONE ASSEMBLY

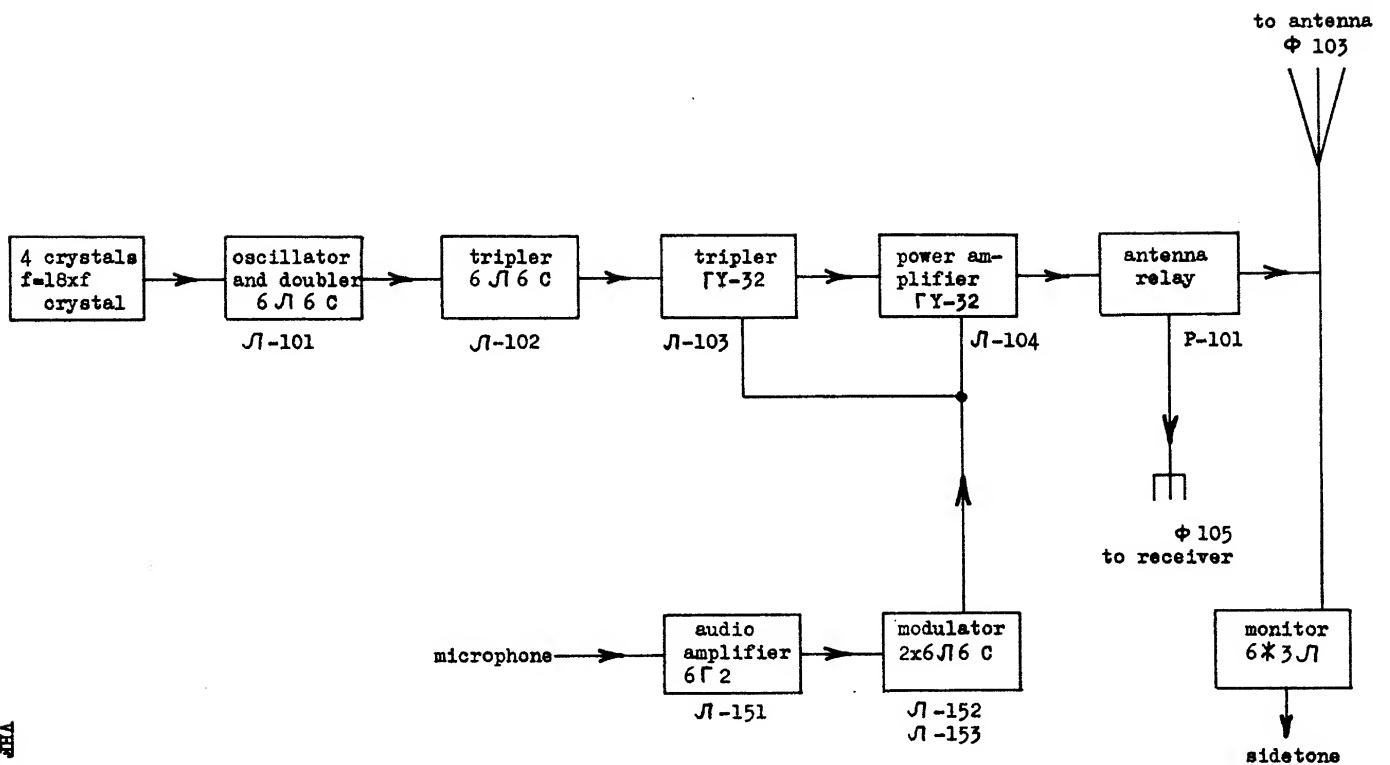
Fig. 3-11.  
SECRET

VHF SET RSI-U-3M.  
BLOCK DIAGRAM OF  
TRANSMITTER.

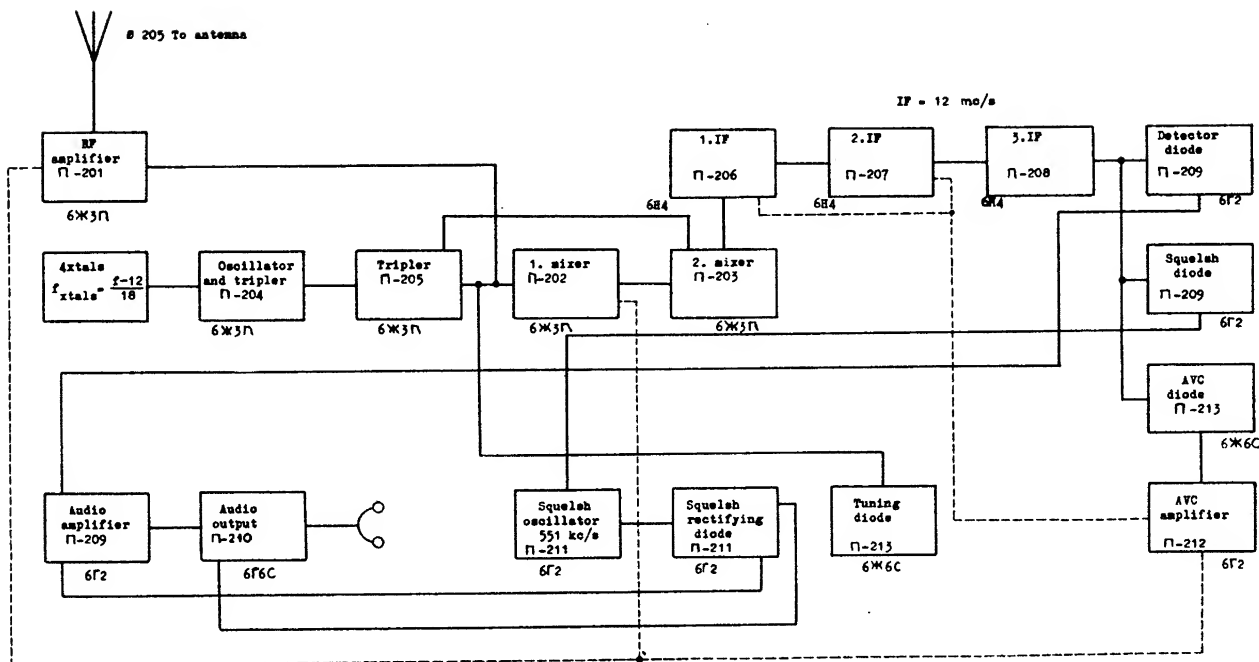
Fig. 3-12.  
SECRET

The signal was then amplified in a 3 stage IF amplifier and was detected in a diode detector, after which it was amplified in an audio amplifier, which, in turn, fed the output tube. The receiver was equipped with a squelch circuit, making the receiver "dead" when no signal was being received. The AVC was amplified in an AVC amplifier, which was applied to the RF, 1st mixer, 1st IF and 2nd stages.

SECRET  
VHF SET RSI-U-3M.  
BLOCK DIAGRAM OF RECEIVER.

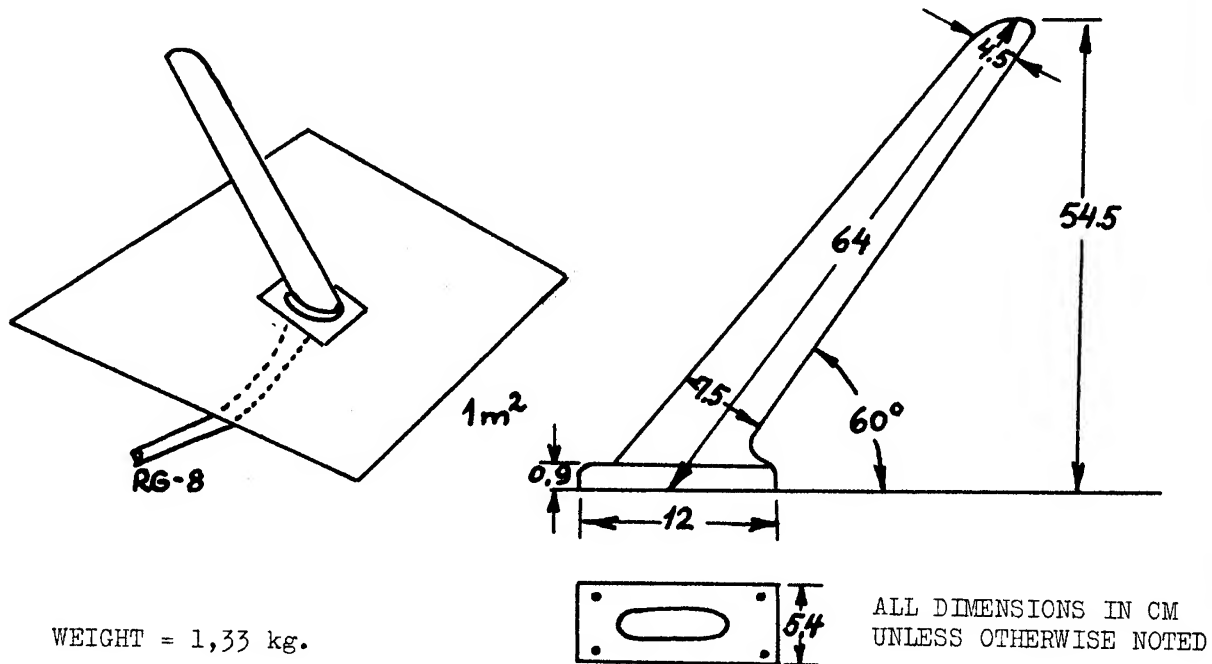
Fig. 3-14.

VHF SET RSI-U-3M.  
SWR. FOR VHF ANTENNA.

SWR measured with 7m, RC-8 cable Antenna mounted  
on a 1m<sup>2</sup> aluminiumplate placed 2 m above ground.

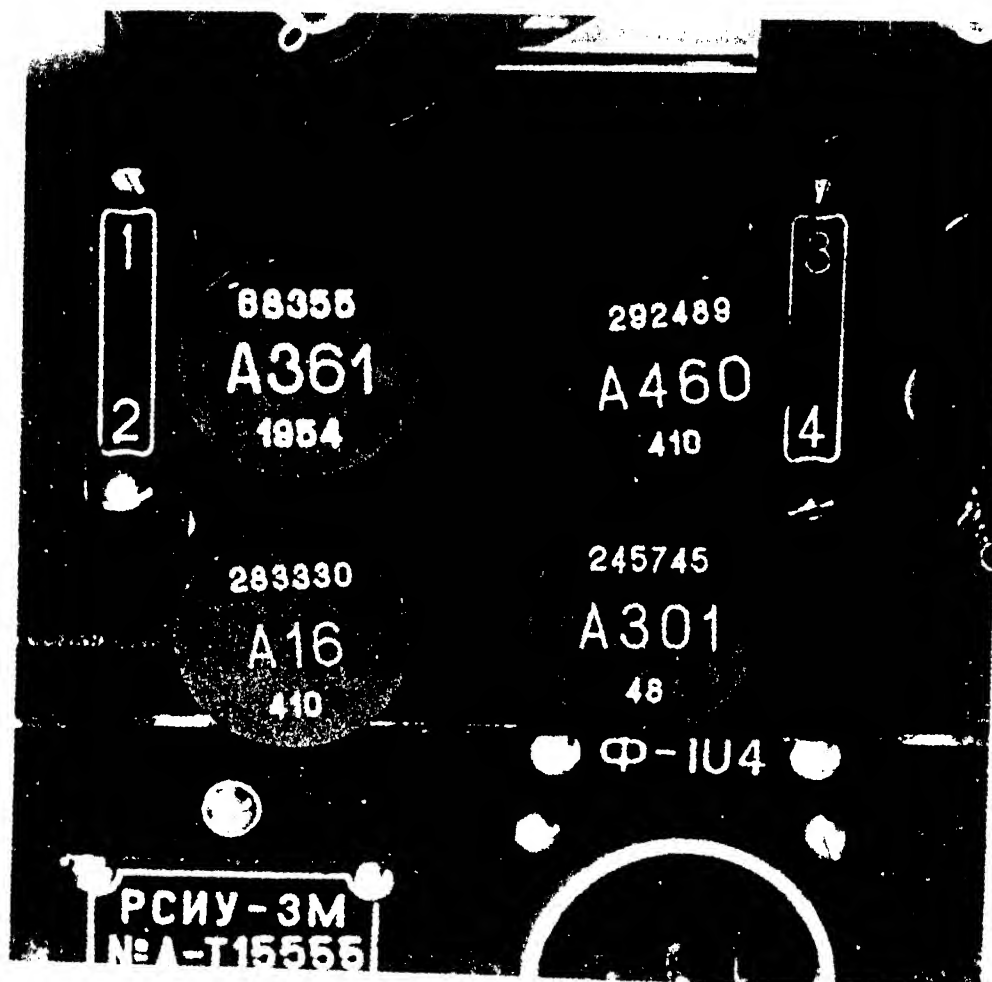
Fig. 3-16-1  
Transmitter Crystals.

The crystal inventory card, Fig. 3-16, reveals that only channel numbers which correspond to multiples of 250 KC (3 x 83,33 KC) were included in the spare crystal kit.

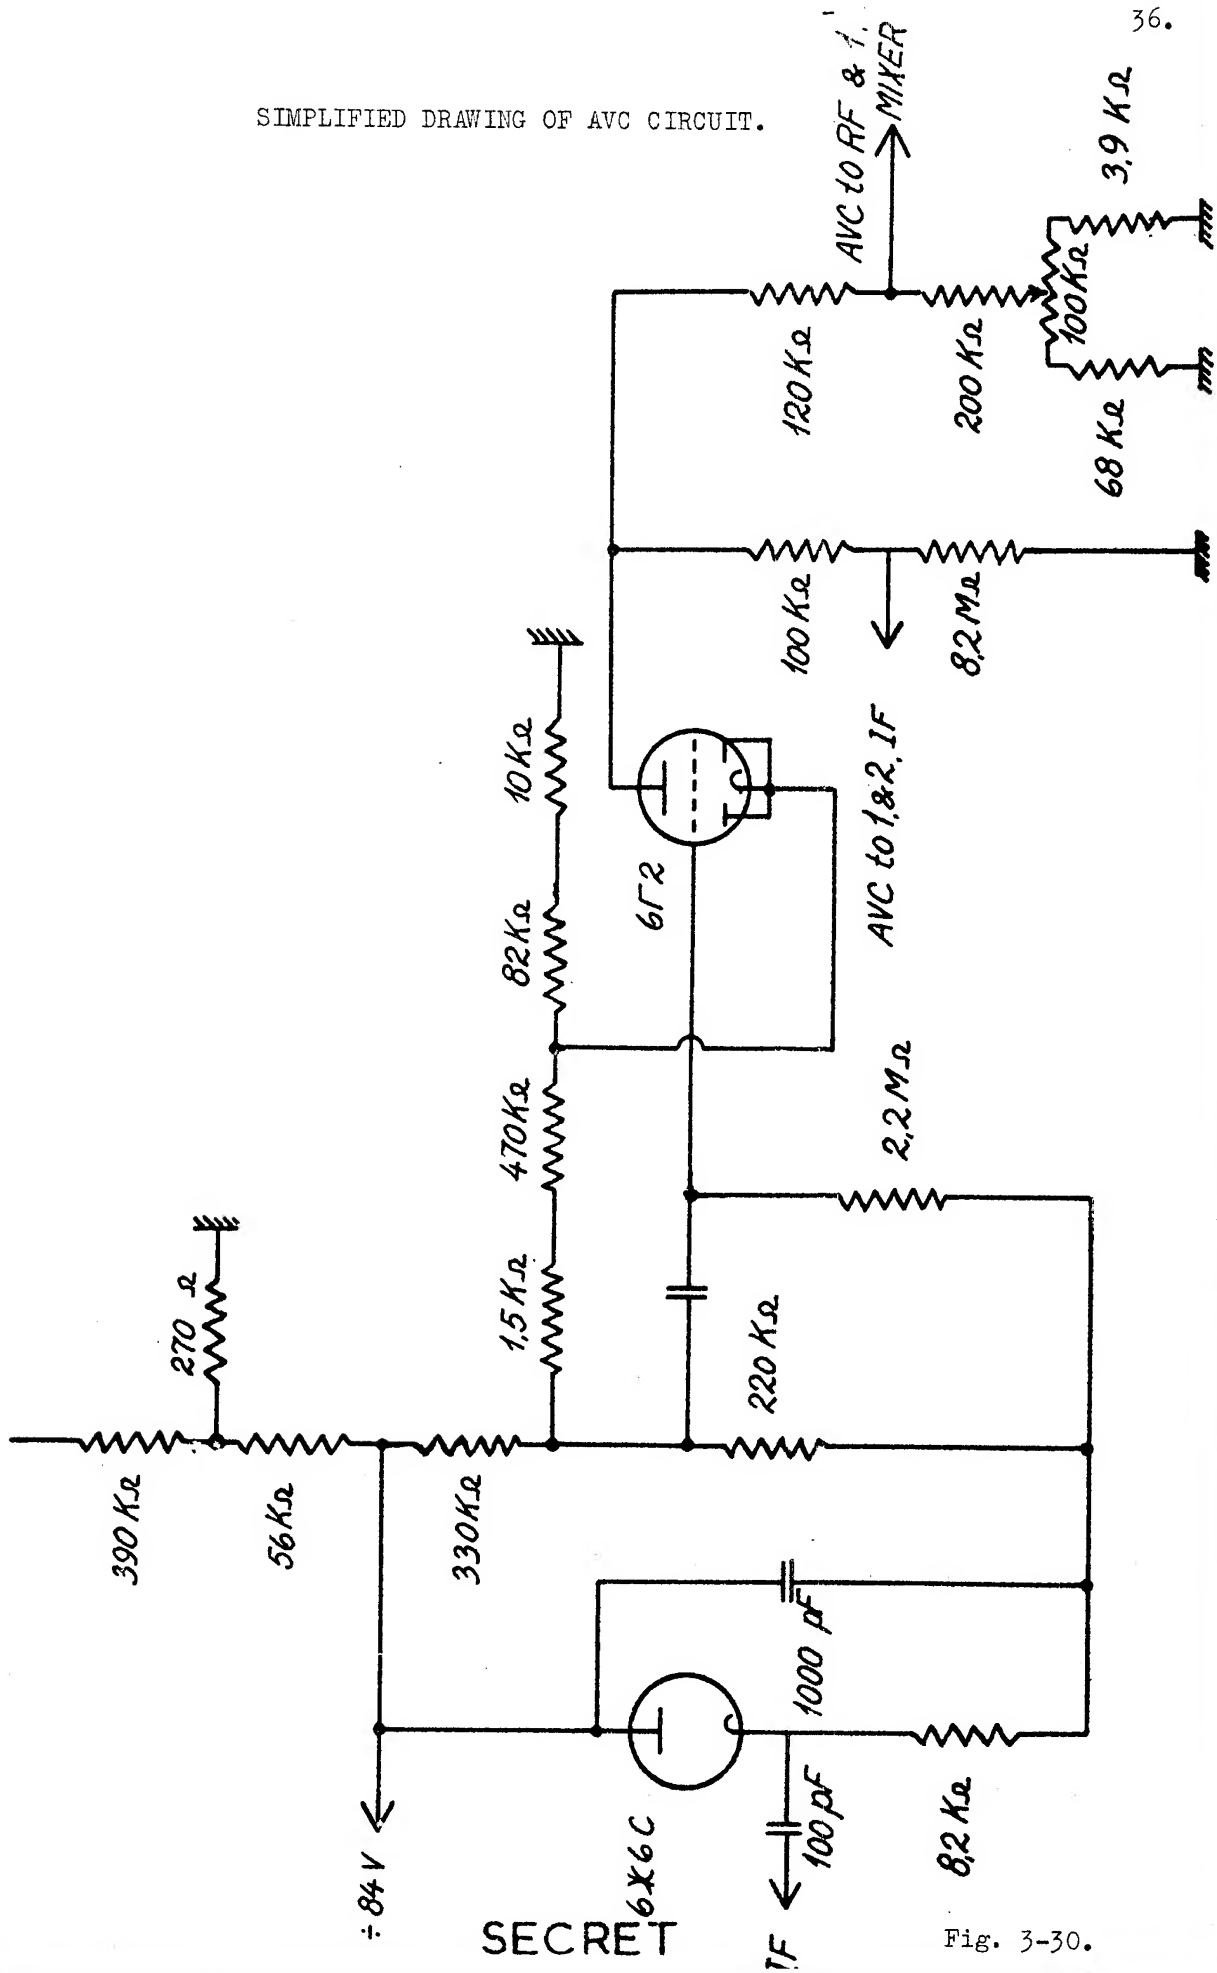
Fig. 3-30.

SIMPLIFIED DRAWING OF AVC CIRCUIT.
